Design of a System for Checking Paint Results on the Ship's Hull to Prevent Corrosion

Abstract: Corrosion is damage caused by chemical reactions between metal materials and other natural elements and is destructive to metal. Corrosion is a weakness in ships made of steel, namely because the rate of ship corrosion, fatigue life is reduced, tensile strength and other mechanical properties are reduced. Corrosion is concentrated on only certain parts. In metal corrosion current flow out onto other parts of the metal surface. Corrosion gastric plates result in reduction Hull panel strength, slowing the ship and reduces security guarantees. The hull must be protected from corrosive attacks routine to prevent loss of additional plates substantially due to seawater corrosion. For Prevent hull corrosion in the painting process for coating, cathodic protection process. In this article, a system for automatically detecting ship hull painting results using image processing is explained. This system will be developed into a portable system. The results obtained show that the system is able to recognize whether the painting results can be accepted or rejected. Accepted means no need to repaint.

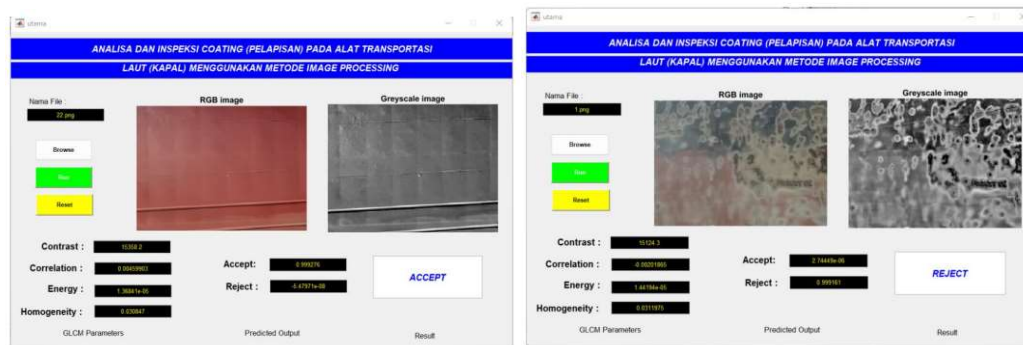
(a)

(b)

The neural network was then tested to determine its ability to distinguish between suitable coating conditions and those that require repainting. The test results show that the entire image processing process that has been carried out is able to differentiate between conditions that are acceptable (accept) and those that are not suitable (reject) and require further treatment.
